Safata District

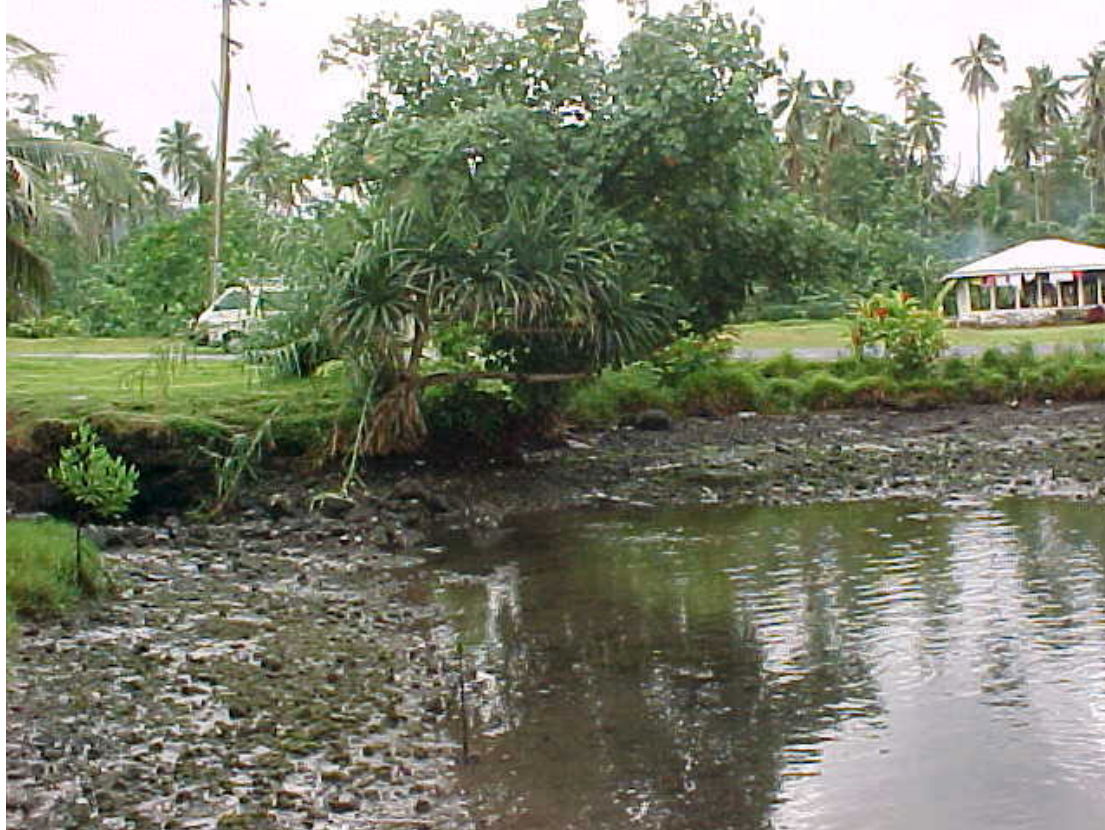
Dangerous corner eroding behind spring.

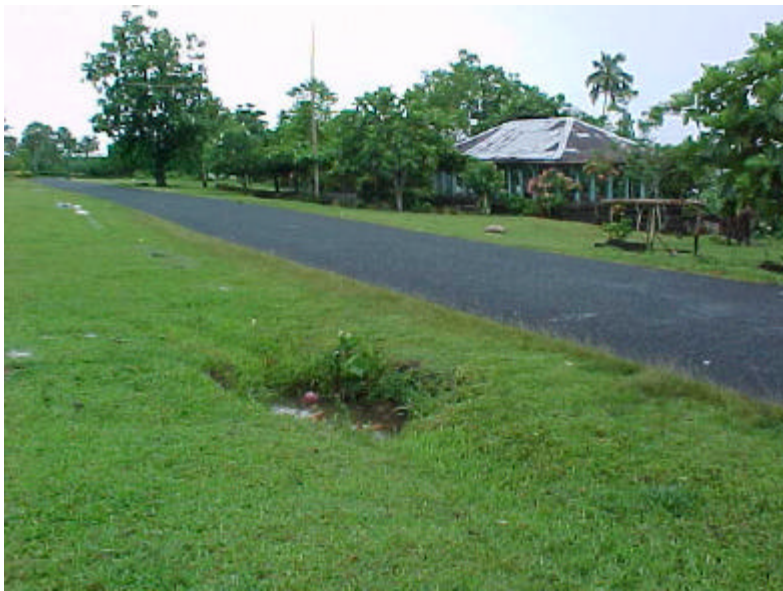
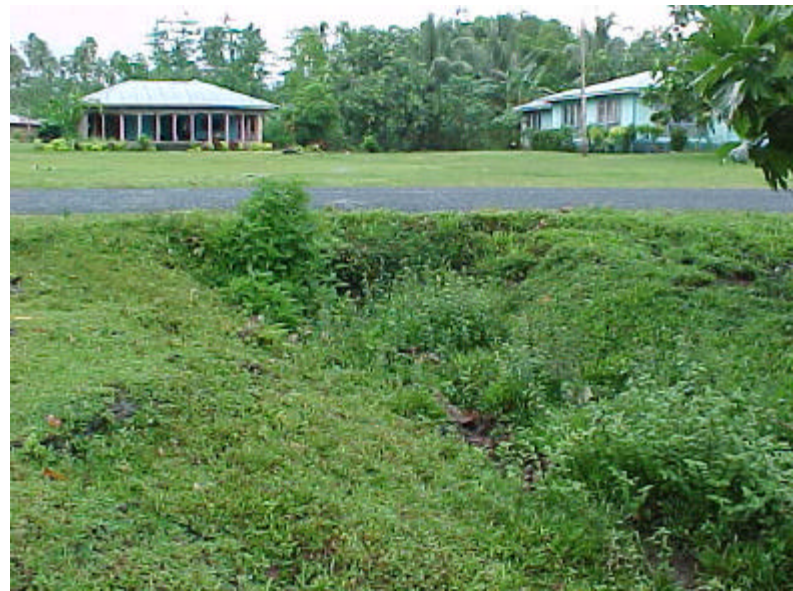
Blocked culvert on Main South Coast Road. Left photo inland side – right photo seaward side.
