Monitoring of coastal hazards zones in Samoa

*Leoo Polutea & Jude Kohlhase**

Purpose

The main purpose of this study was to revisit and monitor areas of the coastal hinterland that have relatively high sensitivities and have been subjected to natural coastal hazards over the last four years.

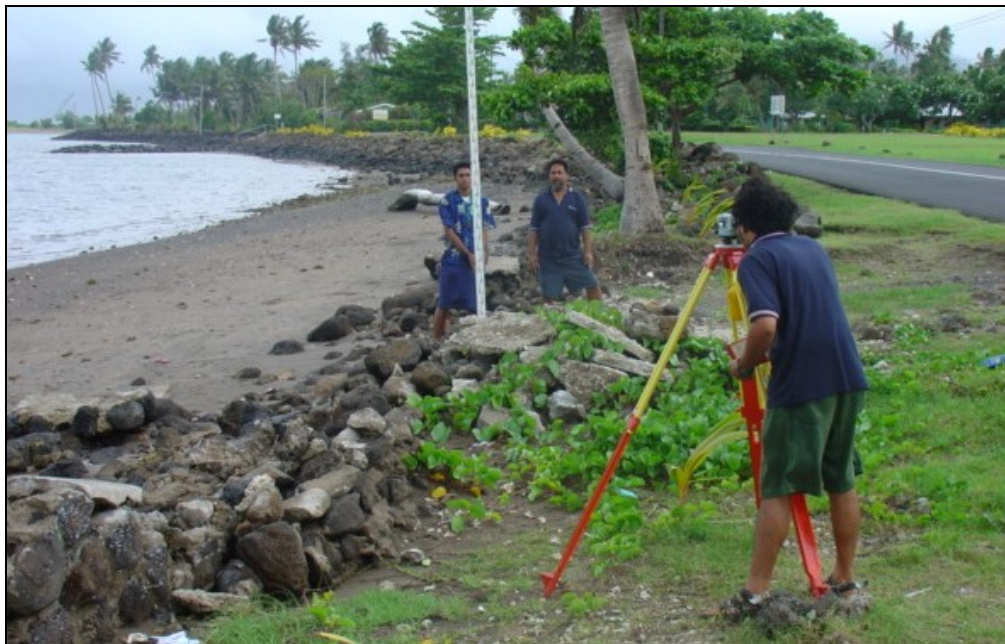
Figure 1: Leveling work carried out at L19 station. This image illustrates part of the vertical seawall severely damaged during cyclone Heta in 2004. Petania Tuala, Senior Mapping Officer has the instrument and the chainmen with the staff. Photo taken at Vaiala Beach, Upolu.

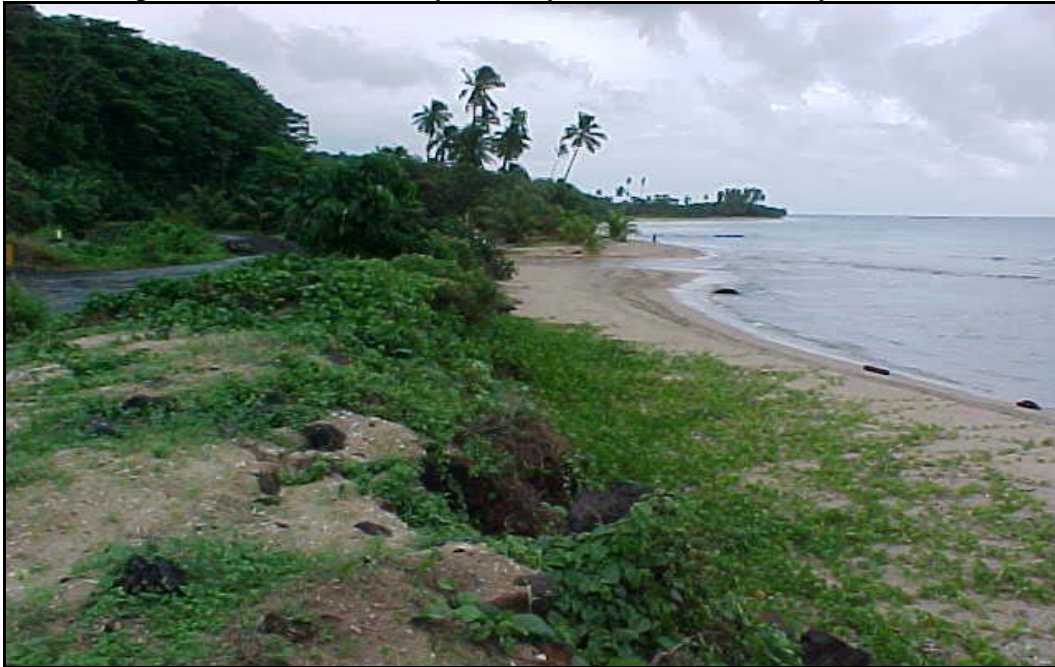
During this study the nearby vegetation (coconut) used to cover the area as seen in the photographs in 2000 has been removed and sand continue eroded inland (retreat) and replaced the small swamp area used to be at this place (refer to photograph taken in 2000 and 2004).

Figure 3: C5 station at Manase with significant vegetation growth in 2000. Note: The 8 mature coconut palms. Photo taken July 2004 by MNRE CHZ Survey Team

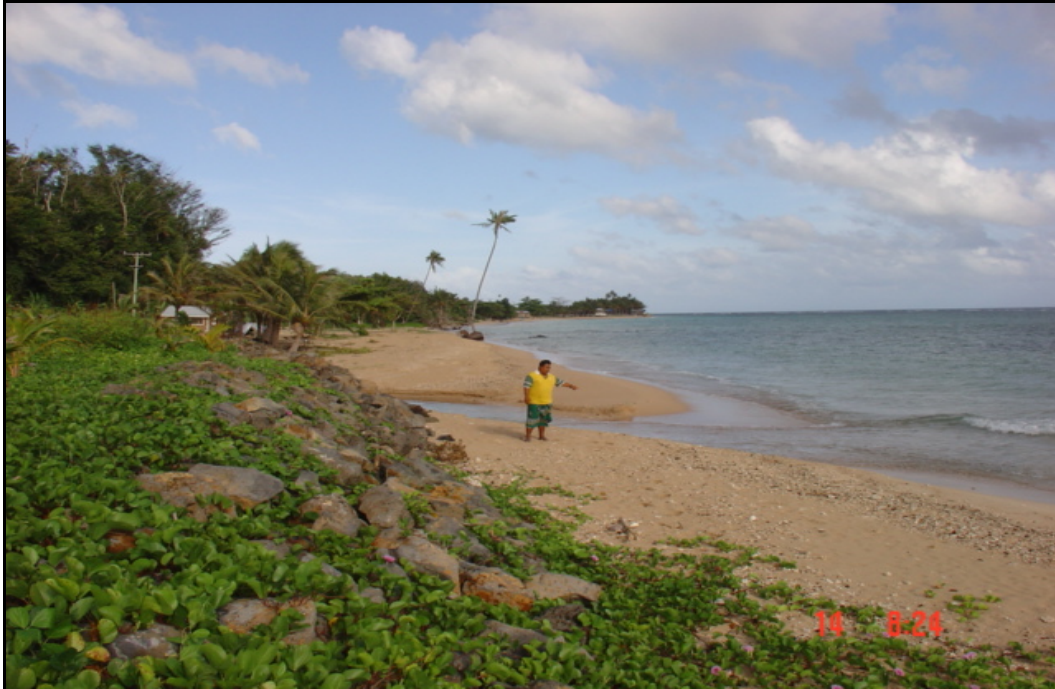
According to the interviews held with the people from Manase and Saleia, this station was found severely affected by waves during the most recent cyclone Heta in 2004 and river flooding from the streams nearby in 2001.

One other significant change discovered in this area was the position of high tide which has been shifted to almost two meters inland.

Figure 4: Image of the CHZ Station at Manase. Note: In comparison to the image above only 1 coconut palm is firmly supported in the dune while the other coconut palm's support is clearly eroded. Photo taken July 2004 by MNRE CHZ Survey Team.
