### Faasaleleaga 1 District

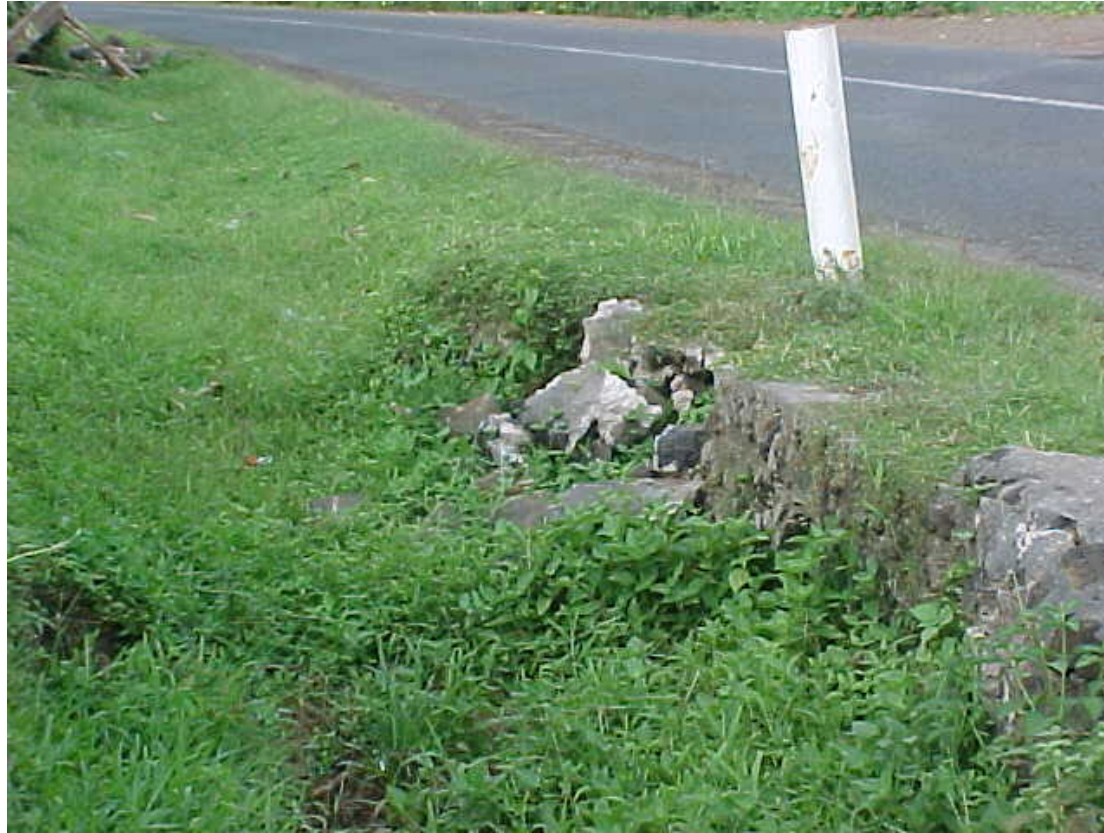
Blocked drain behind road at Saletagaloa.

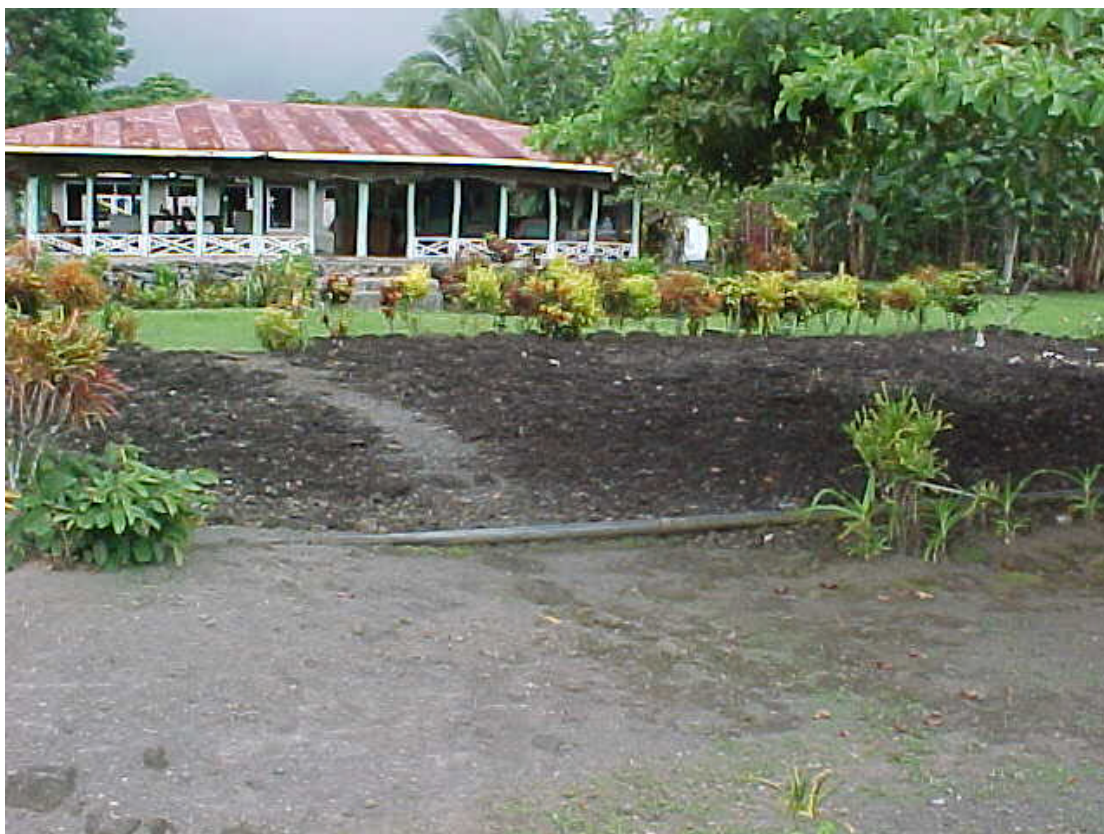
Flood area behind road at Vai'afai caused by culvert outlet invert being lower than surrounding ground levels. Exposed galvanised water pipe to be replaced by new PVC pipe under the EU Rural Water Supply Project.
