**Gagaemauga II District
Sale'aula Village**

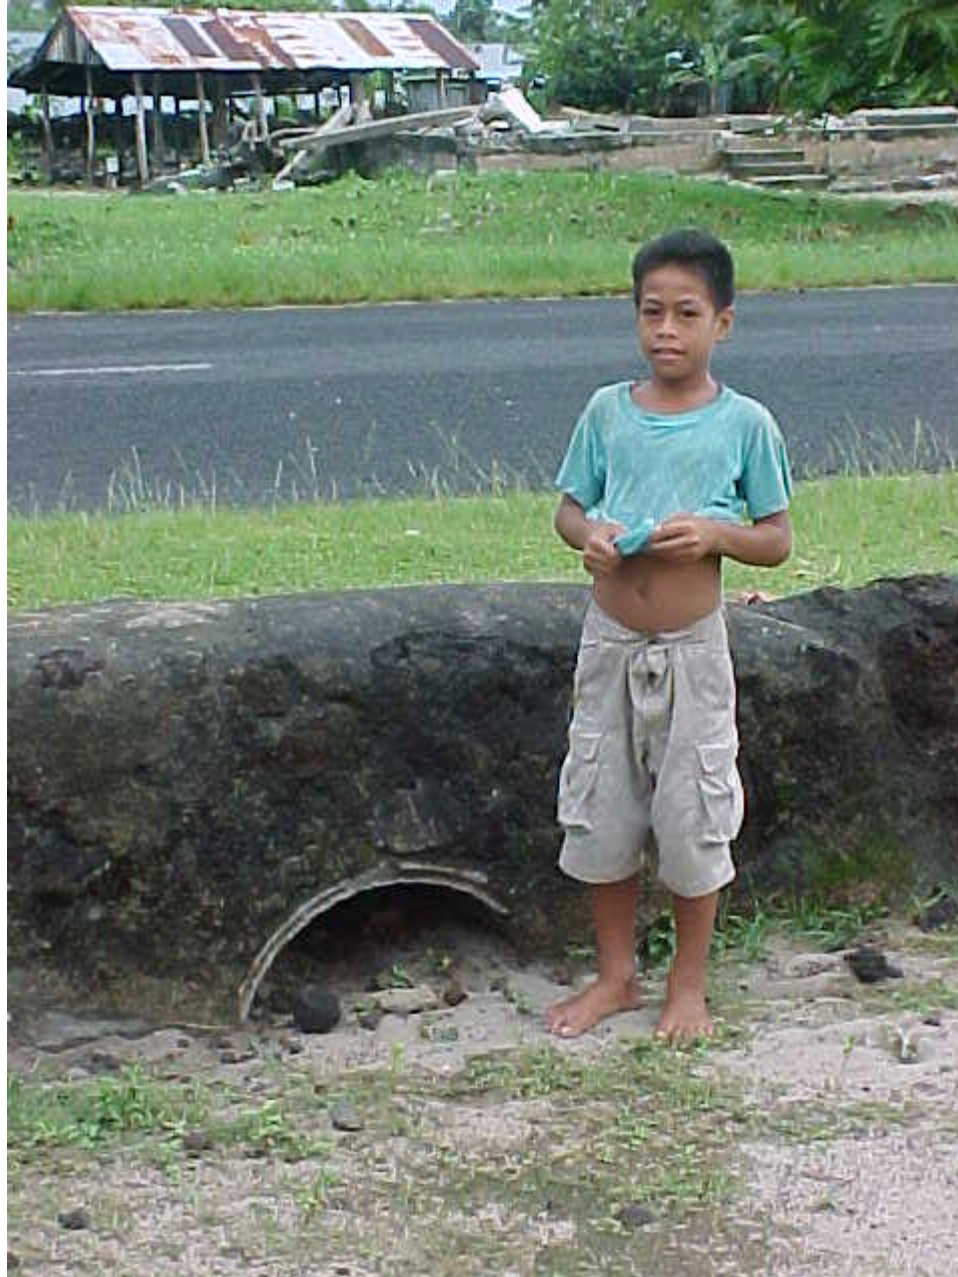
Blocked drain behind road at Sale'aula.

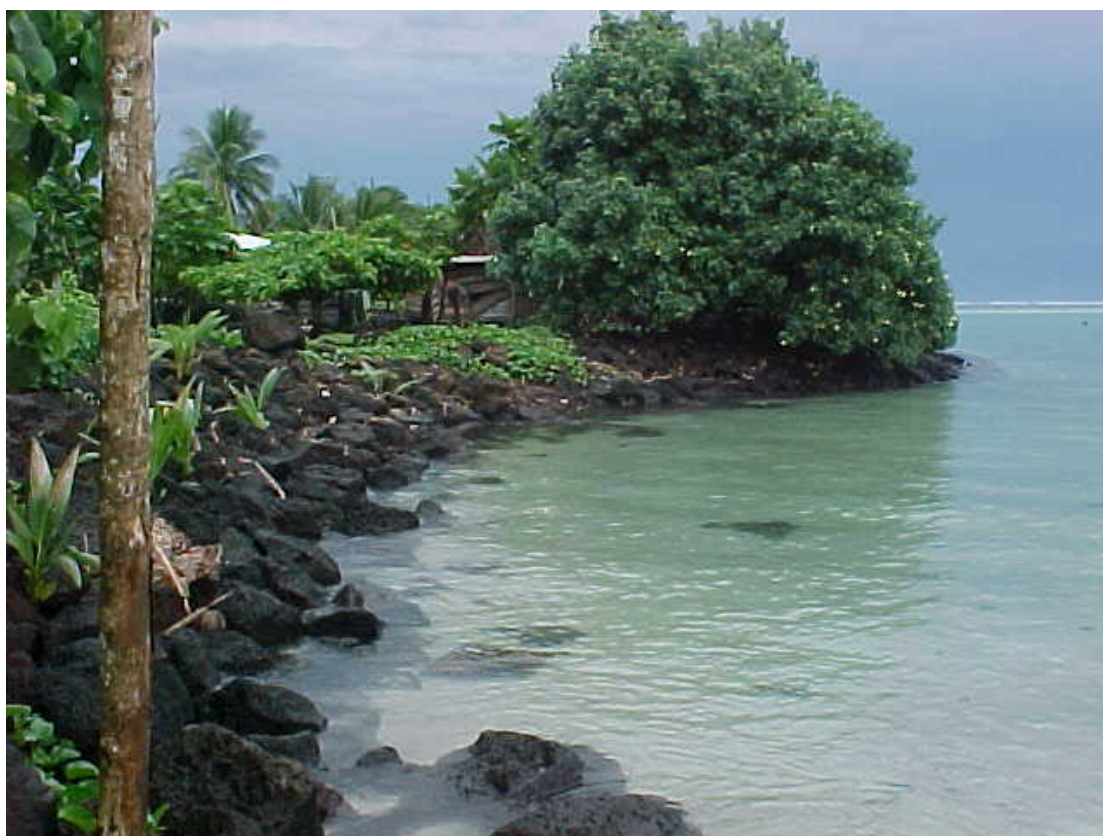
Seawall at Sale'aula in good condition follows original coastline. Area behind seawall built up for new Main Road with dredgings from the lagoon.
